Glimmingehus

A Building-Archaeological Investigation of the Interior

BY SARA LIND & TINA WESTERGREN

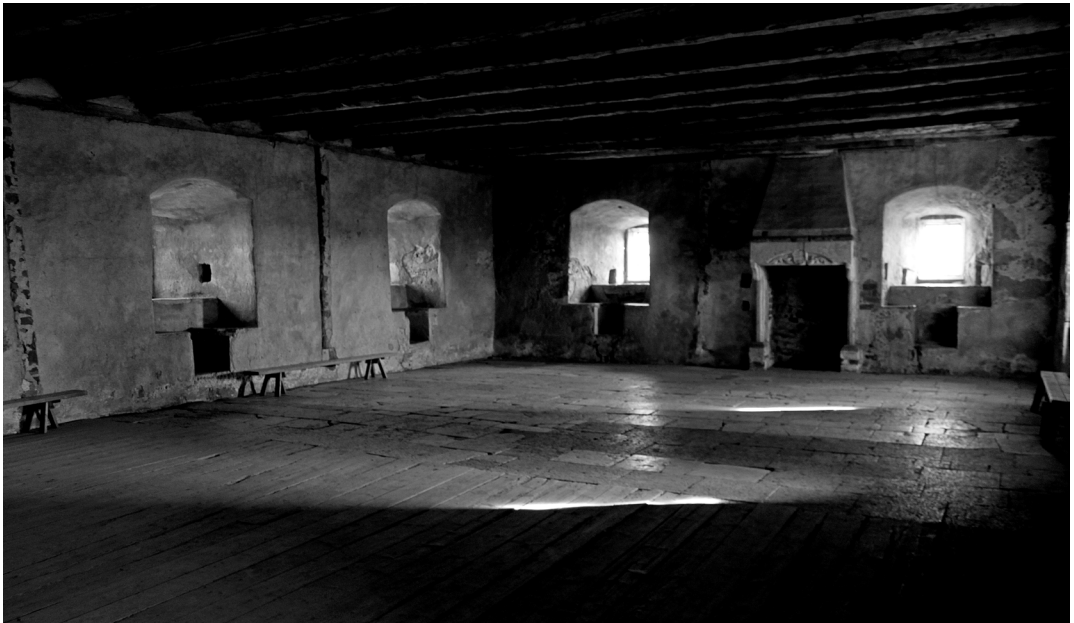
of vertical strips made of mortar and bricks. The interpretations of these walls have varied – Brunius thought them to be original, and thus dividing the big room into five smaller ones, perhaps used as guestrooms (Brunius 1850, pp. 444 f.), while Hildebrand in 1884 interpreted the walls as secondary. Gunilla Gardelin came to the same conclusion in her investigation in 1997, although she interprets the plaster in the room as contemporaneous with the remains of the interior walls. In her interpretation the plaster was added some time after the building was finished (Gardelin 1997, p. 18).

Fig. 6. Room 1 (301) photographed from the western part of the room. Notice the fireplace and the vertical stripes of mortar and bricks. Photo by S. Lind 2012.

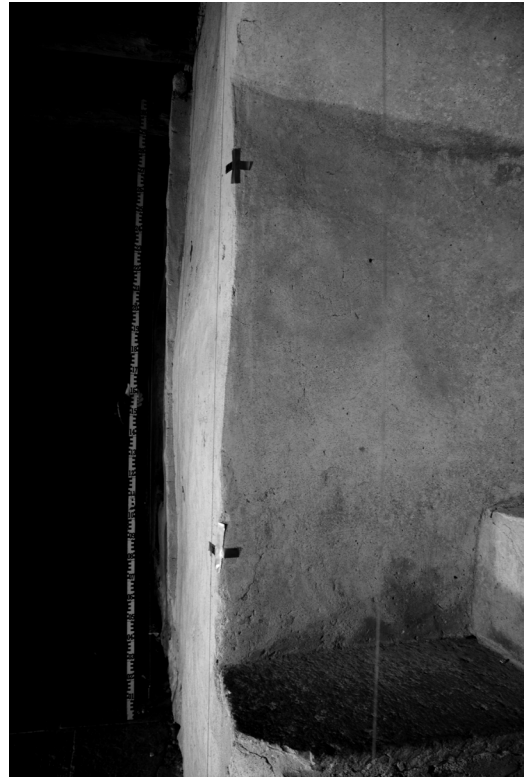
of our investigation in Room 1 (301) was to establish the stratigraphy of the relation between the plaster and the vertical mortar stripes (Fig. 7). The stripes can be found at five places in the room, and on several of them there are traces of a wooden structure, visible in the mortar. Apart from the stripes, there are traces of a removed structure on the western wall close to the entrance to the “Lady’s Chamber” (302). Although no trace except the negative impression of a structure remains here, it is likely to have been the same kind of construction as the remaining mortar stripes. Since the stripes have impressions of a wooden structure, and are all vertical on the surface facing the room – unlike the exterior wall which they are attached to – we interpret them as a vertical course, built between the uneven exterior wall and the timber in the interior wall to equalize and connect the walls (Fig. 7). The interior walls were probably half-timber work, like the remaining interior wall located at the staircase (see below). Parts of the plaster can at some places be found covering the vertical courses, dating them as older than the plaster. The plaster itself seems to be original, the first layer of plaster in the room – nowhere have we found any traces of an earlier layer. Instead the same plaster covering parts of the remains of the interior walls sits directly on the exterior walls. Since it is unlikely that the room was used without a layer of plaster – all the “finer” rooms of the castle are plastered – this most likely dates the plaster as original and therefore the interior walls are original as well. It is also possible to date the plaster after 1503, since it covers the edges of the stone plaque bearing the coat of arms of Jens Holgersen’s mother marked with the year – the plaque being an original part of the exterior wall (Fig. 8).

Fig. 7. The easternmost of the vertical courses on the north wall of Room 1 (301) photographed from the east. Photo by T. Westergren 2011.

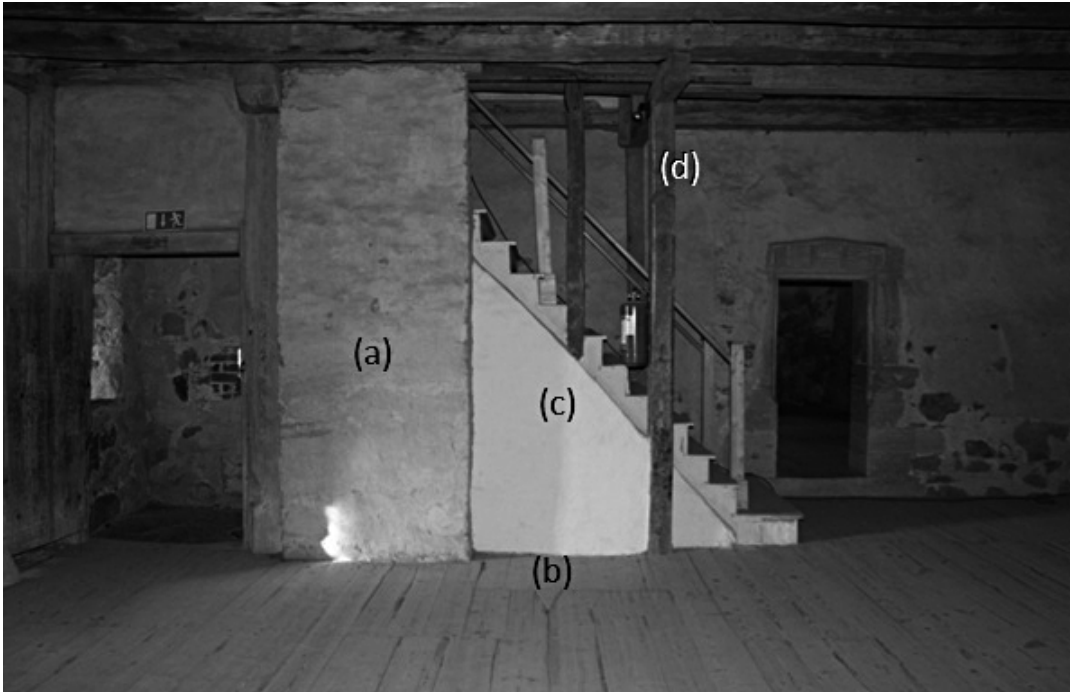
Fig. 10. The staircase photographed from the eastern part of Room 1 (301). The chimney has continued up through the floor just north of the supporting pilaster (a) – a square in the wooden floor (b) can be seen where it once went up. Notice the new plaster and stairs (c) leading up to Room 2 (401), and the remains of the supporting wooden structure (d) at the base of the stairs. Photo by S. Lind 2012.

part of the room since the common opinion is that it has been changed and is hard to understand (Nilsson 1999, p. 23). The chimney from the kitchen in the basement once lined the stair but is now cut underneath the wooden floor in Room 1 (301). Next to the chimney a piece of wall, 128 cm wide and 55 cm deep, is preserved. On its northern side there are still clear marks of the bricks and joints of the chimney, and it could possibly be a supporting pilaster built secondarily to the chimney – the chimney at that point in time going all way up to the ridge of the roof (Fig. 10).

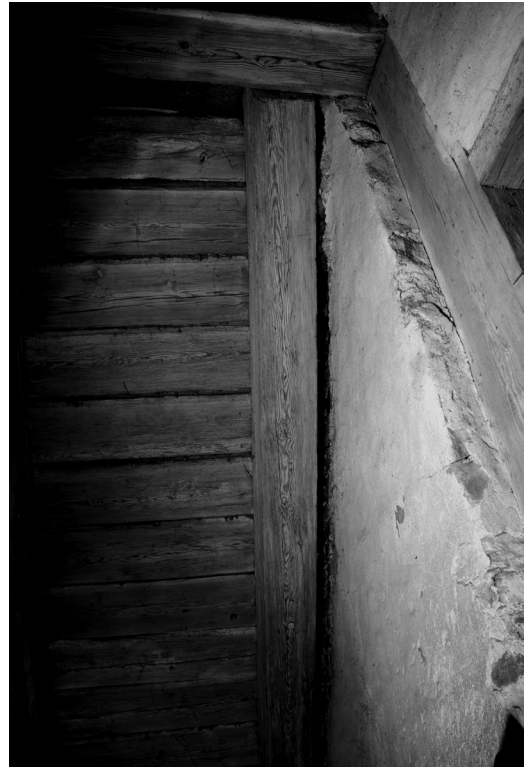
Fig. 11. The stairs leading from Room 1 (301) to Room 2 (401) photographed from underneath, the plaster of the supporting pilaster not reaching up under the supporting beams in the stairway. Notice the substantial beam which the staircase rests upon at its upper end, and how it is joined with the half-timber structure above the doorway. Photo by T. Westergren 2011.

covered with plaster added secondarily to the stairs between second and third floor, since the plaster does not continue up under the supporting joists (Fig. 11).

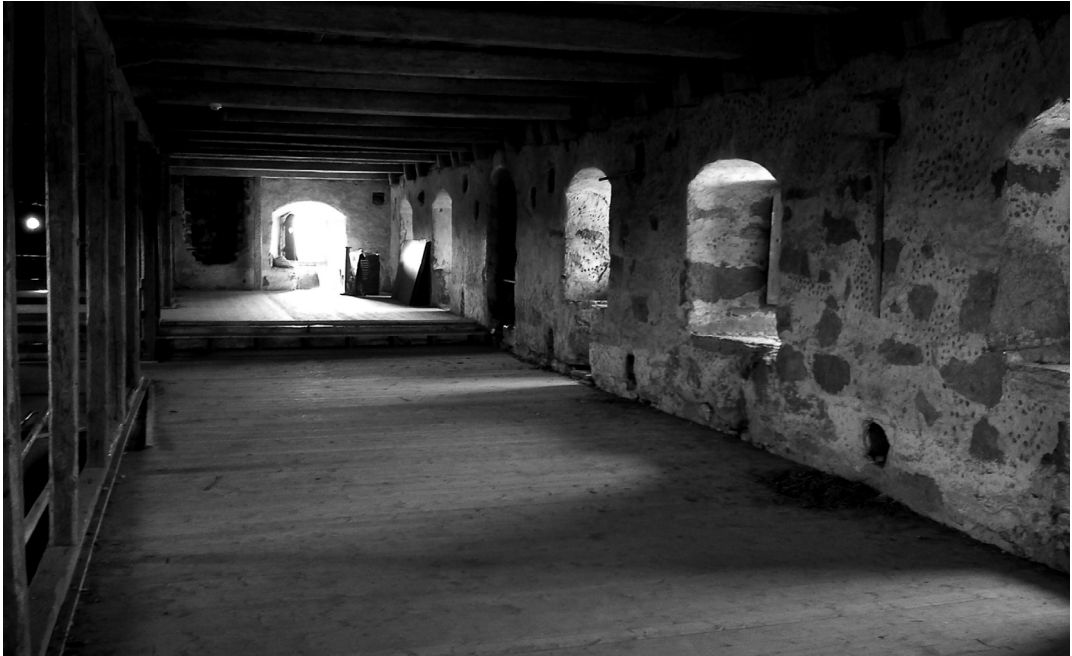
Fig. 12. Room 2 (401) photographed from the eastern part of the room, showing the northern half of “the Archers’ Loft”. Notice the holes between the windows, placed in pairs, and the posts of the truss ending with a faced side, a little beneath the top of the wall – the beams going across the ceiling lying loose on top of the wall and supporting the secondarily built attic. Photo by S. Lind 2010.

Room 2 (401) is the only room in the building to cover an entire floor (Fig. 12). The oldest plaster in this room, according to the stratigraphy, appears to be the same kind of plaster as the original layer in room 1 (301). No traces of any earlier plaster could be found in Room 2 (401) either.

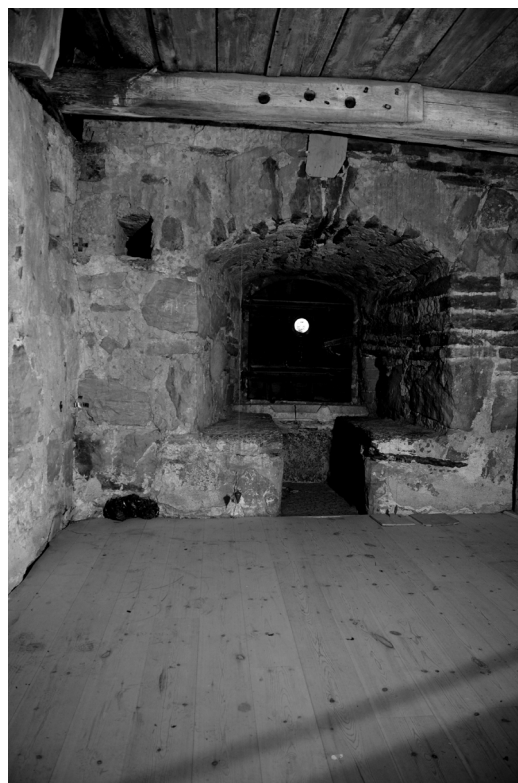
Fig. 13. One of the windows in the west gable of Room 2 (401), with the local limestone in the embrasure, photographed from the east. Photo by T. Westergren 2011.

butt joints visible in some places against the original exterior wall – observations made by Gardelin in 1997 as well (Gardelin 1997, p. 21). In many of the windows the stones used for benches and embrasures seem to be secondary as well. Some of them are reused, with holes for iron bars identifying them as originally being parts of window frames. The windows in the eastern and western walls are different, though – here the embrasures and benches are mainly made of the almost black local limestone, Komstad lime, and appear to be primary (Fig. 13).

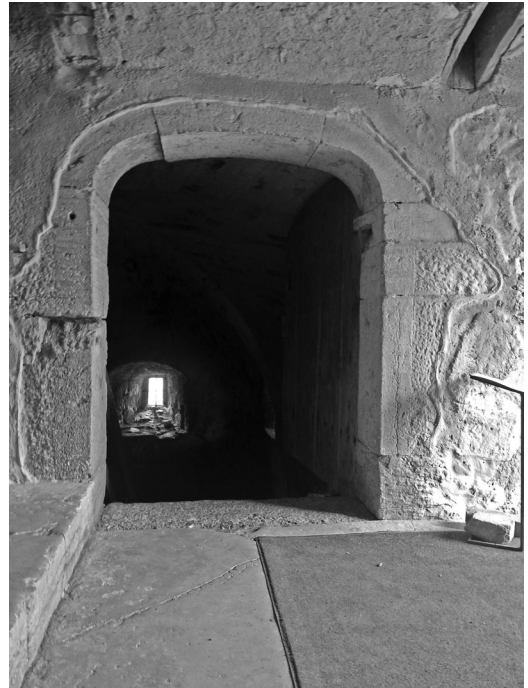
Overall, the survey shows the importance of documenting and the fact that there will always be new questions to ask, and new answers to get – even at a well-investigated place like Glimmingehus. Sadly the castle is not protected by law from changes today, even though applications to change this have been sent to the Swedish Government. This means that changes are still made to the castle without any documentation being done. All the modern changes described in this article – new floors and stairs – have been made without any antiquarian supervisor. And in the spring of 2013 renovations of the lower parts of the staircase were begun, a new layer of plaster being added in the entrance hall and stairs, without any documentation being done (Fig. 15).

Fig. 15. The latest changes made at Glimmingehus – a new layer of plaster in the entrance hall was applied in spring 2013 without any documentation being done. Photo by S. Lind 2013.
