# Shadow Paintings: A Neglected Type of Wall Painting

*Elisabeth Andersen & Susanne Kaun*

*Abstract* The article presents the results of a pilot study focusing on what are called *shadow paintings* in Norwegian church interiors from the 17th and 18th centuries. Among the many Baroque illusionistic wall paintings in churches, painted shadows are probably the least known and considered. Shadow paintings are grey or black paintings that surround church furnishings, such as altarpieces, epitaphs and sculptures, as well as pulpits and stalls. They create an illusion of light by “casting” a shadow behind an object, thus enlarging and accentuating the object. Most of the original shadow paintings were overpainted or removed during the 19th century, but in the 20th century many were rediscovered and successively revealed. Remnants of shadow paintings are found in several northern European countries. In Norway, nineteen visible shadow paintings have been preserved, offering an understanding of how these wall paintings were formed, executed and popularized. Aside from their decorative character, painted shadows can supply greater knowledge about the church furnishings. But above all, shado

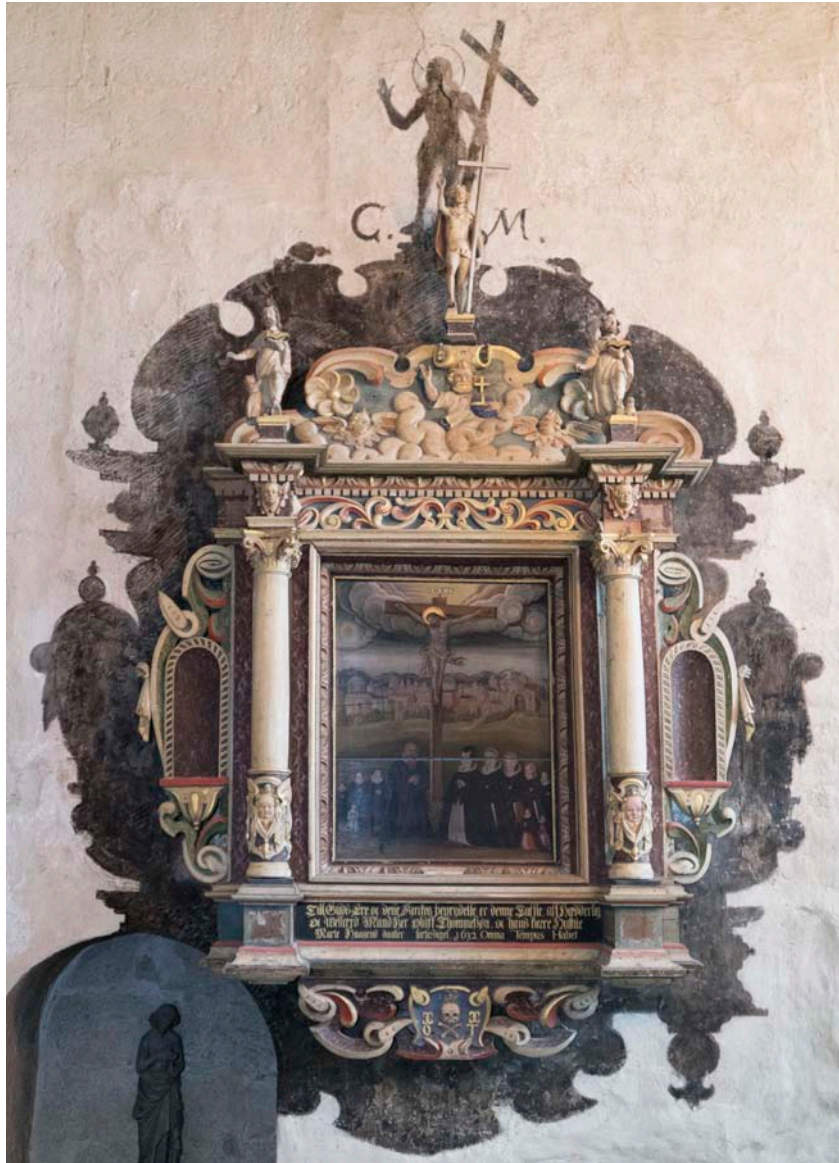
Fig. 1. Ringsaker Church in Hedmark. Shadow painting surrounding an epitaph from 1632.  
Photo Susanne Kaun, NIKU.

In Ringsaker Church, Hedmark, a shadow painting was discovered and revealed in 1959. Upon close examination, one can see that the shapes of the shadow and the epitaph, from 1632, do not correspond exactly to one another: the shadow has spheres not present on the epitaph today, and the

two evangelist figures at the top of the object are not seen in the shadow painting (fig. 1).

If a shadow reflects the outline of the object, the epitaph in Ringsaker Church must have undergone several changes, and, indeed, a photo of the epitaph taken before 1955 reveals no evangelists.<sup>22</sup> One theory is that the evangelists were originally part of the old pulpit that was replaced by a new one in 1704, and that the evangelists were mounted on the epitaph lat-

er.<sup>23</sup> The epitaph has also been dismantled and stored at some point, so perhaps the spherical decorations were broken off or removed during storage. Remnants of what appear to be wooden plugs may indicate the earlier presence of spherical decorations as shown in the shadow.

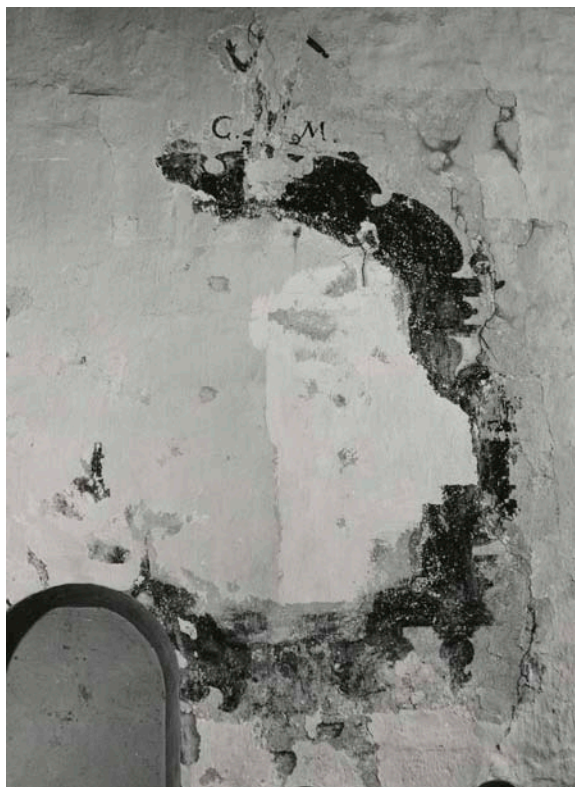
Fig. 2. Shadow painting in Ringsaker Church during uncovering in 1959. Photo Ola Seter, 1959, Directorate for Cultural Heritage (Riksantikvaren) Archive, Norway.

and as a result it was crucial for this study to identify original and secondary paint.<sup>15</sup> During the nineteenth century, nearly all of the Norwegian wall paintings, including shadow paintings, were whitewashed or painted over with white paint. It was not until the early twentieth century that older wall paintings were rediscovered and successively uncovered. Often, only fragments of shadow paintings were preserved, and in some cases, new shadows were creatively painted based on traces of black paint found on the wall.<sup>16</sup> In other cases, enough original paint was found to

restore the original form, as in Ringsaker Church, Hedmark (fig. 2).

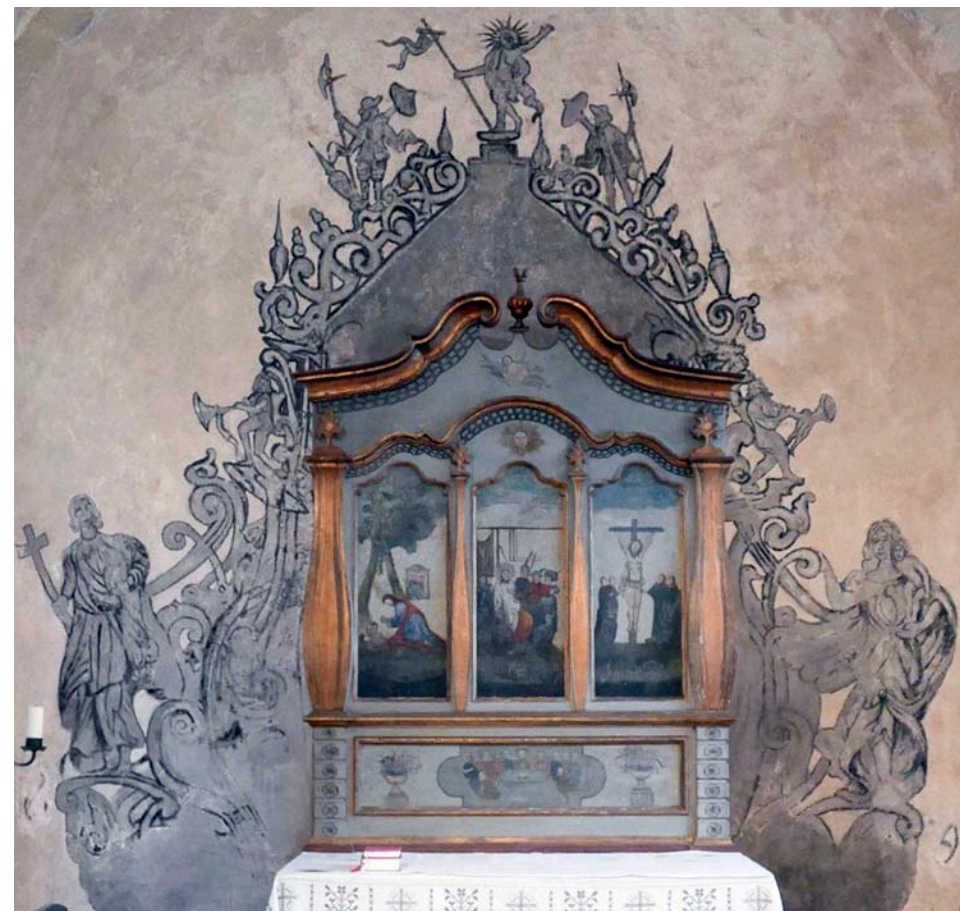
Fig. 3. Efteløt Church in Buskerud. Grisaille framing from the 17th century surrounding an altarpiece (1787) from Komnes church. The original altarpiece once belonging to the grisailles in Efteløt are today lost. Photo Susanne Kaun, NIKU.

ow paintings. As an example, art historians and conservators have often wrongly referred to the grisaille frame in Efteløt Church, Buskerud (fig. 3), as a shadow painting.<sup>17</sup> Grisaille frames are executed in different shades of grey or greyish colours, or, as in Efteløt Church, grey with black contours and gradations of grey colour, giv-

ing an illusion of sculptures and ornaments. A shadow painting, on the other hand, consists of monochrome paint, not painted as a frame, but meant to give an illusion of a shadow thrown by the object. This differentiation is important to remember when examining shadow paintings.

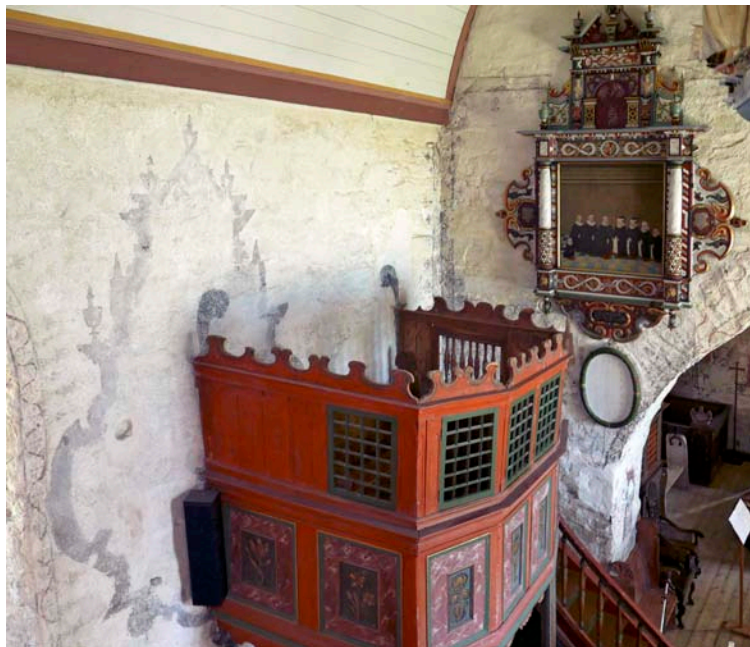
Fig. 4. Dale Church in Luster, Sogn og Fjordane. The abandoned shadow painting on the north wall (left in the photo) belongs to the epitaph from 1630, hanging on the north side of the chancel-screen (top right on the photo). Photo Susanne Kaun, NIKU.

In Dale Church, three painted shadows have been preserved; they were paired with an earlier altarpiece (as noted above), a stall and an epitaph since moved. The epitaph is from c. 1630, but the wings were

probably mounted later, around 1650.<sup>21</sup> Given that the shadow follows the shape of the epitaph's wings, the shadow must have been painted in connection with this remodeling.

In 1699, to make room for a stall, the epitaph was moved from its original place, on the north wall of the nave, to the north side of the chancel-screen, where no new shadow was painted (fig 4). However, a shadow

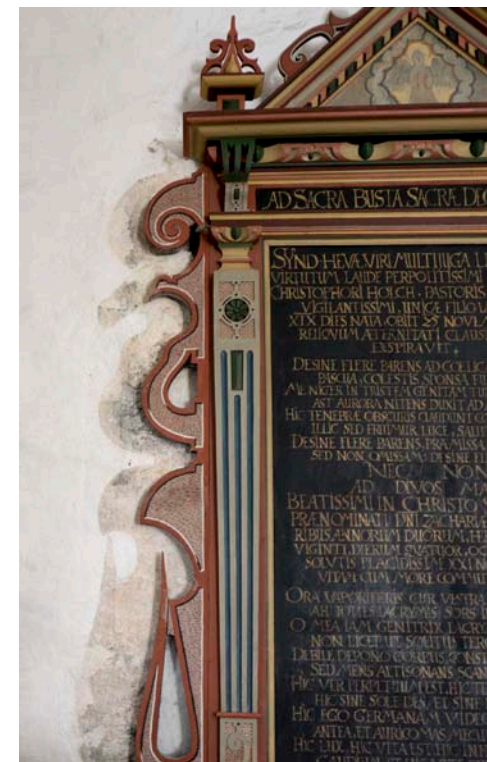
Fig. 5. Veøy Church in Møre og Romsdal. The shadow decor surrounding an epitaph from 1623. Photo Susanne Kaun, NIKU.

The earliest object in Norway with a preserved shadow painting is an epitaph from 1623 in Veøy Church (fig. 5); and the last known shadow painting in Norway surrounds an altarpiece in Hof Church, from the mid-eighteenth century. But did an item acquire its shadow when it was new, or could it in some cases be a later supple-

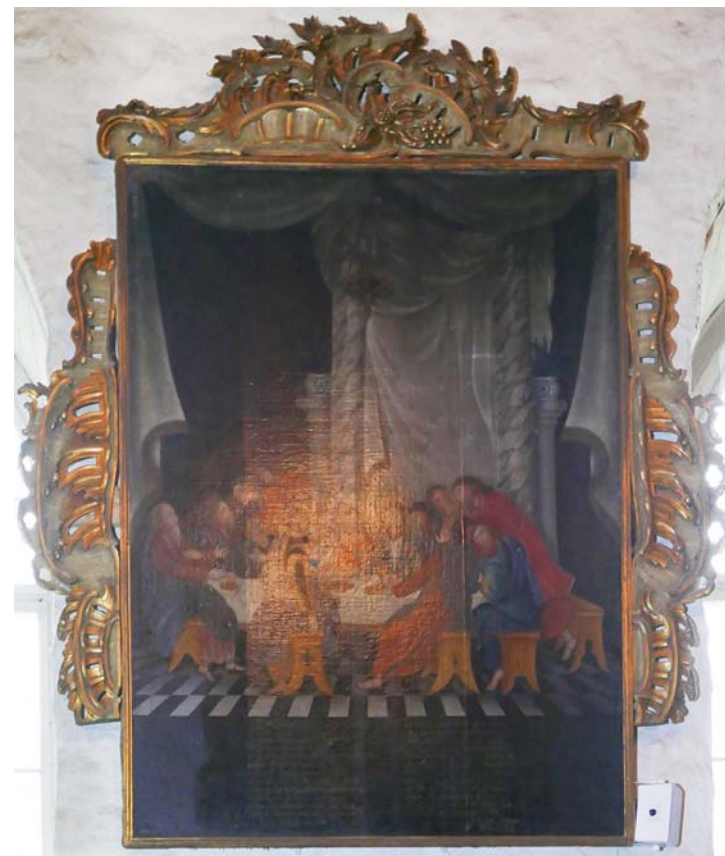
Fig. 7 a–b. Hobøl Church in Østfold. To the left (p. 50): the shadow painting behind today's altarpiece. To the right: the altarpiece from 1761 with rococo wings mounted upside down. Photos Susanne Kaun, NIKU.

In Hobøl Church the shadow painting covers nearly the entire apse in the chancel (fig. 7 a–b). Even though it has been restored with a “generous hand”, there are still sufficient original details to support a

conclusion that the shadow does not belong to the existing altarpiece, but most likely was painted together with another altarpiece dating from 1761, which today is mounted in the nave. Comparing the shadow with the altarpiece from 1761, one can see that the carved rococo wings have been changed at some point. An archival photo

from before its removal, in 1938, confirms that the altarpiece's wings once had been placed the other way around (that is, today they are "upside down"), correlating with the outline of the shadow.

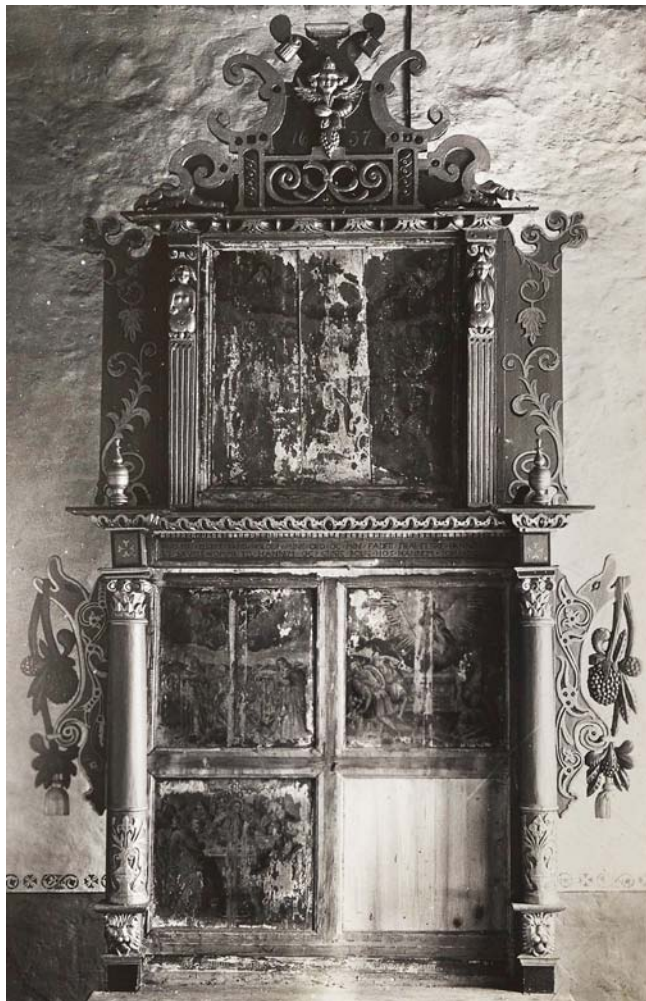
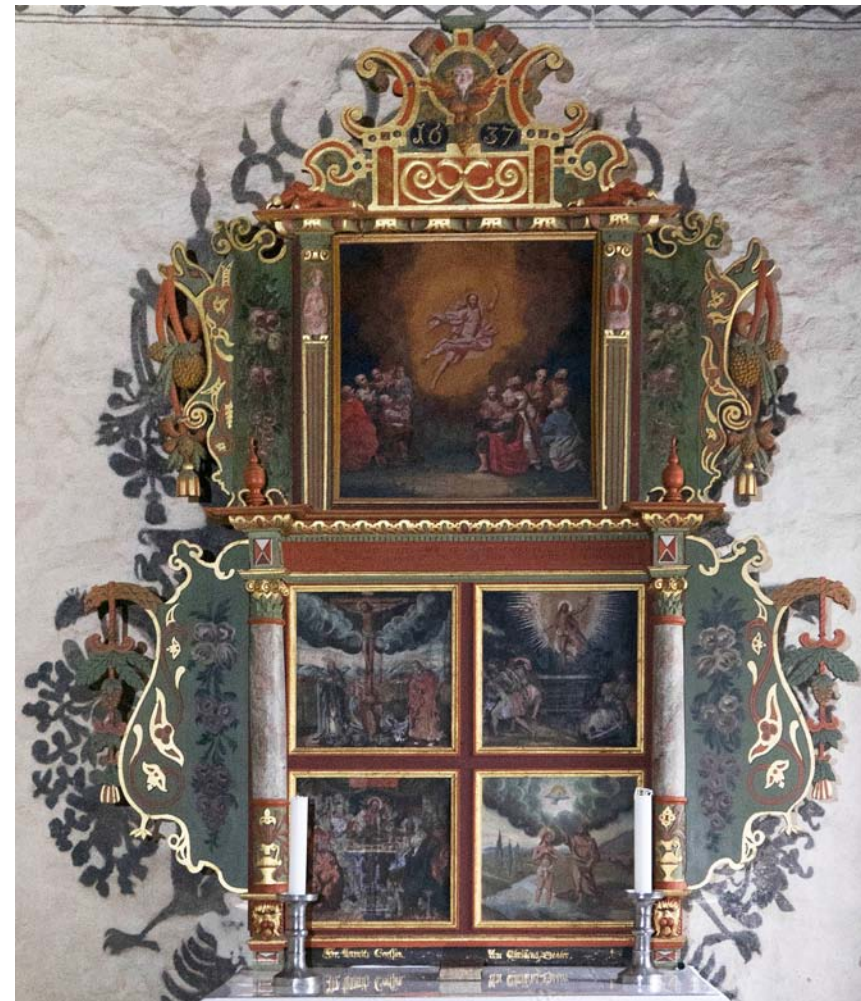
Fig. 8 a–b. Hof Church in Vestfold. The altarpiece before the restoration in the 1940s (to the left) and the altarpiece in 2018 (to the right, p. 53). The shadow painting nearly disappears behind the altarpiece. Photo to the left by unknown photographer, unknown date, Directorate for Cultural Heritage (Riksantikvaren) Archive, Norway. Photo to the right Susanne Kaun, NIKU.

When standing in front of the altarpiece in Hof Church, Vestfold, the shadow painting appears too small for the altar-

piece, thus indicating that the altarpiece has undergone several changes and that its original form must have been narrower.<sup>24</sup> (fig. 8 a–b). When the painted shadow was found and uncovered in 1941–1942, it revealed the original shape of the lost lower wings.<sup>25</sup> In 1959, the lower wings were reconstructed using the shadow painting

as a model, albeit in a simpler form, without the bird claws and feathers. This restoration did not, however, take into consideration that the altarpiece must have been narrower when the shadow was painted. Careful inspection of the altarpiece indicates that the wings have later been widened with rose-painted panels.<sup>26</sup>

The shadow painting in Hof Church is of high quality and appears to have been more elaborately executed compared with other shadow paintings. The shadow was painted when the altarpiece received its wings, perhaps in the middle of the eighteenth century, at the same time new paintings were mounted.<sup>27</sup> This makes the Hof shadow one of the youngest shadows preserved in Norway. But when compared with the shadow painting in Veøy Church (fig. 6), the one in Hof is less faithful to the shape of the wings, but only in its detailing.
