The Bishop's Brick House

Remains of Medieval Buildings on the River Bank of Koroinen, Finland

BY TANJA RATILAINEN, VISA IMMONEN, KIRSI SALONEN, AND JANNE HARJULA

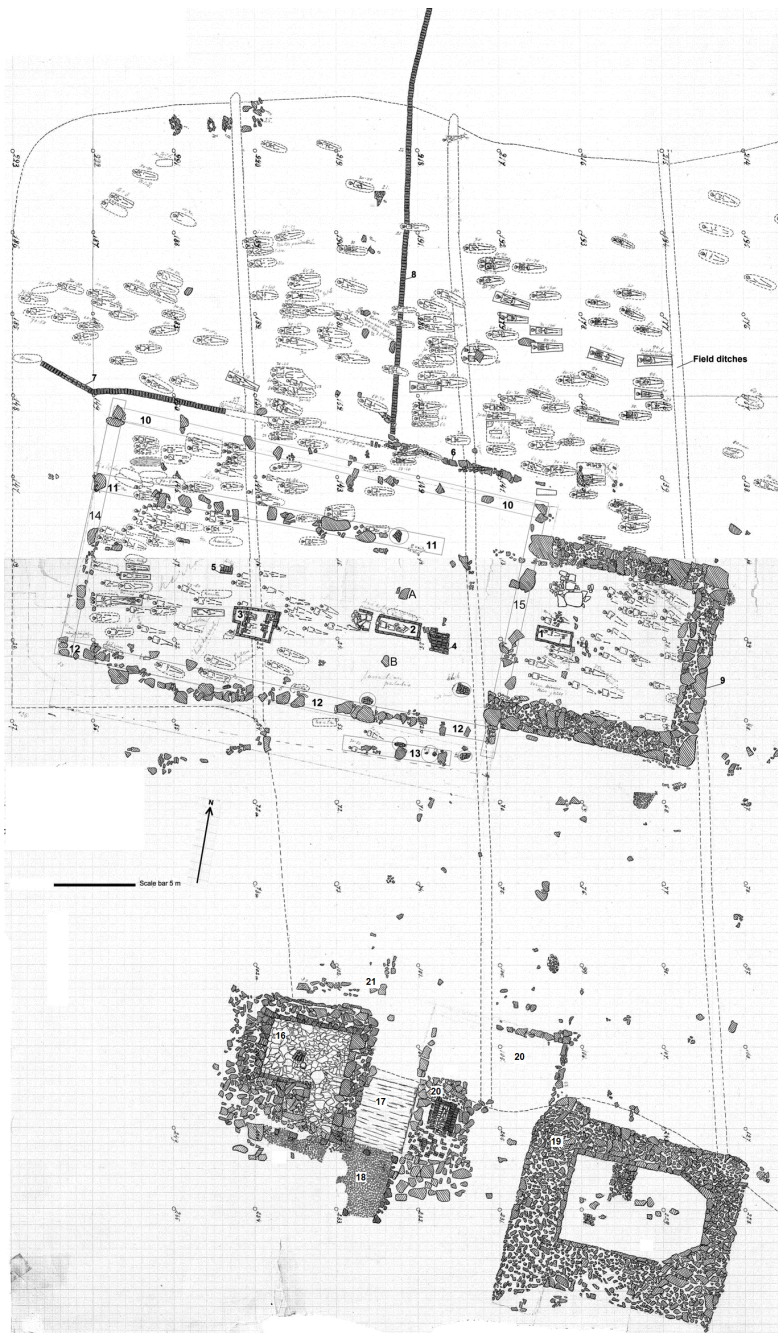
Fig. 3. Locations of the structures at Koroinen: 1–3 = brick-walled grave; 4 = altar foundation; 5 = foundation for a baptismal font; 6–8 = subsurface drain; 9 = foundation of a masonry building; 10–12 = stone foundations of wooden naves; 13 = line of stones, function open; 14–15 = stone foundations of wooden naves; A, B = possible corner stones of a narrow chancel; 16 = western masonry building; 17 = wooden level; 18 = rubble stone area; 19 = eastern masonry building; 20 = wooden building with a heat-storage hypocaust; 21 = vague building remains excluded from the article. Scale bar 5 m. Map by J. Rinne, National Board of Antiquities, modified by T. Ratilainen.

It seems feasible that a brick altar (no. 4 in Fig. 3) was built in the narrow chancel of the first wooden church, probably 20 by 10.5 m (nos. 11–12, 14 in Fig. 3), located at the centre of the cape. One of the three known brick-walled graves (no. 2 in Fig. 3) was constructed in the chancel. The second wooden church (nos. 10, 12, 14–15 in Fig. 3) measured approx. 27.5 by 14.5 m, and it probably had a narrow wooden chancel as well. A brick podium, or the simple foundation of a baptismal font (no. 5) as well as the sub-surface drain (nos. 6–8), made mostly of bricks, were probably contemporaneous with the second church. The cemetery was used before and after the drain was built. The wooden chancel must have been located at the same place where the masonry building, presumably a chancel of stone (no. 9), was built at the end. It is very likely that the chancel was not designed to be tower-height, and perhaps it was never completed because there are neither remains of an altar nor proper foundations for a chancel arch. Moreover, the remaining foundation seems to penetrate through the eastern wall of the wooden nave, and the brick-walled grave (no. 1 in Fig. 3) was actually probably built inside the wooden chancel (Ratilainen 2016). Rinne (1902) states that no layer² of brick waste was found in the area of the stone chancel, which may indicate that the vaulting and the brick details were never laid.

Rinne (1941, 39 ff.) argued that the remains of a masonry building in the west were used as a keep or a defensive tower (no. 16 in Fig. 3), while a wooden storage house was built on its eastern side (no. 17). The rubble pavement (no. 18) near the buildings led from the shore into the fortress. The remains of the building to the east was the bishop's palace (no. 19), also used for defensive functions. The remains of an oven and stone foundations between the two masonry buildings belonged to a post-medieval drying barn (no. 20). The stone structure (no. 21) on the northern side

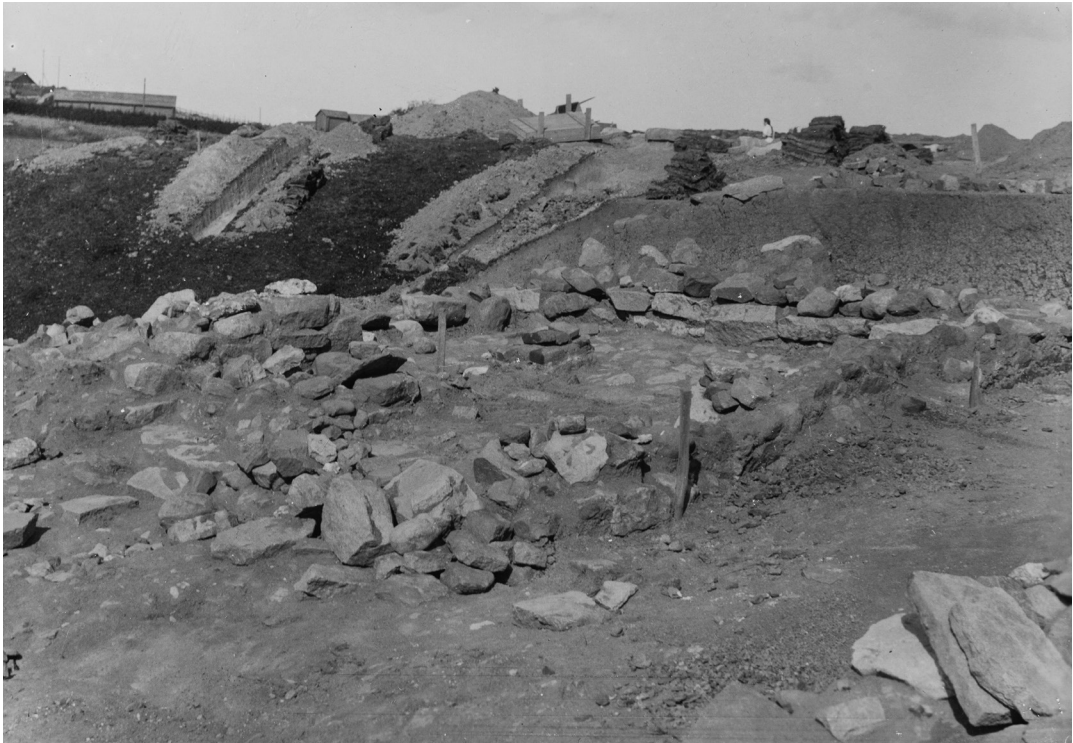
Fig. 6. Western masonry building from the south-east. Structure 16ef on the left and the niche on its south side. Photo by J. Ailio, Museum Centre of Turku.

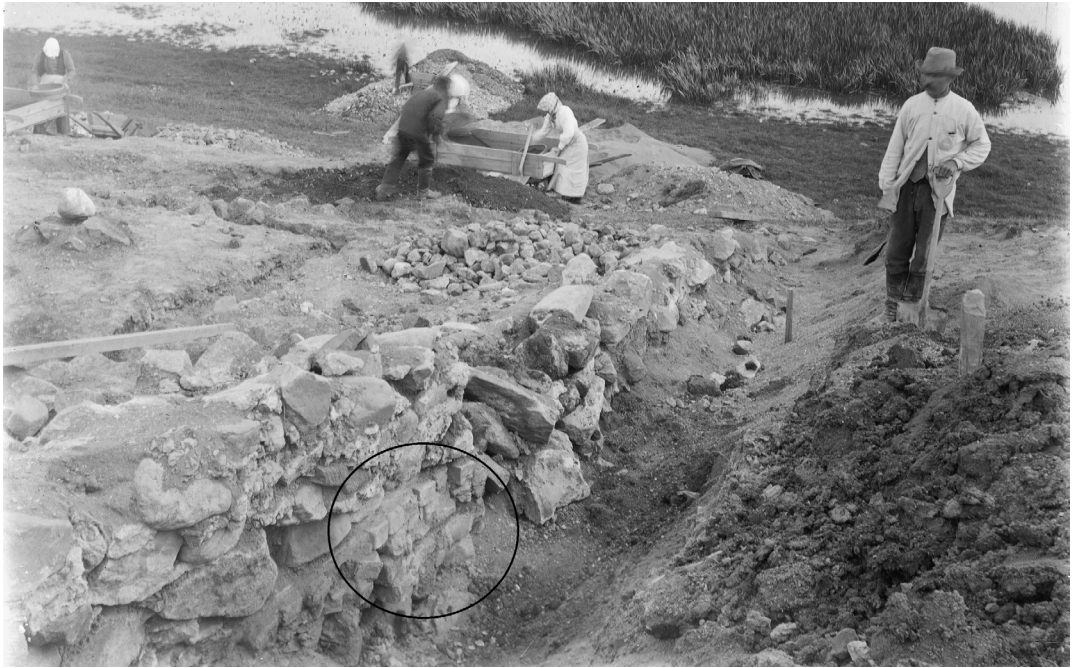
Fig. 8. Foundations of the of the eastern masonry building from the north-west. Note the bricks in the structure. Photo by J. Ailio, Museum Centre of Turku.

Under a massive layer of brick waste (50–100 cm) Rinne discovered the underground foundations of a masonry building divided into two spaces. The eastern one was not rectangular in shape and had three sides (no. 19 in Fig. 7). The remains measured 9 by 5.5 m, and the lower parts of the foundations were 2–3 m in thickness. The remaining walls were mostly erected of stones (Rinne 1941, 42 f.), but Rinne (1902) also recorded that some bricks were used as wedges, and, on the basis of photographs, entire bricks were utilized in the foundations as well (see Fig. 8).

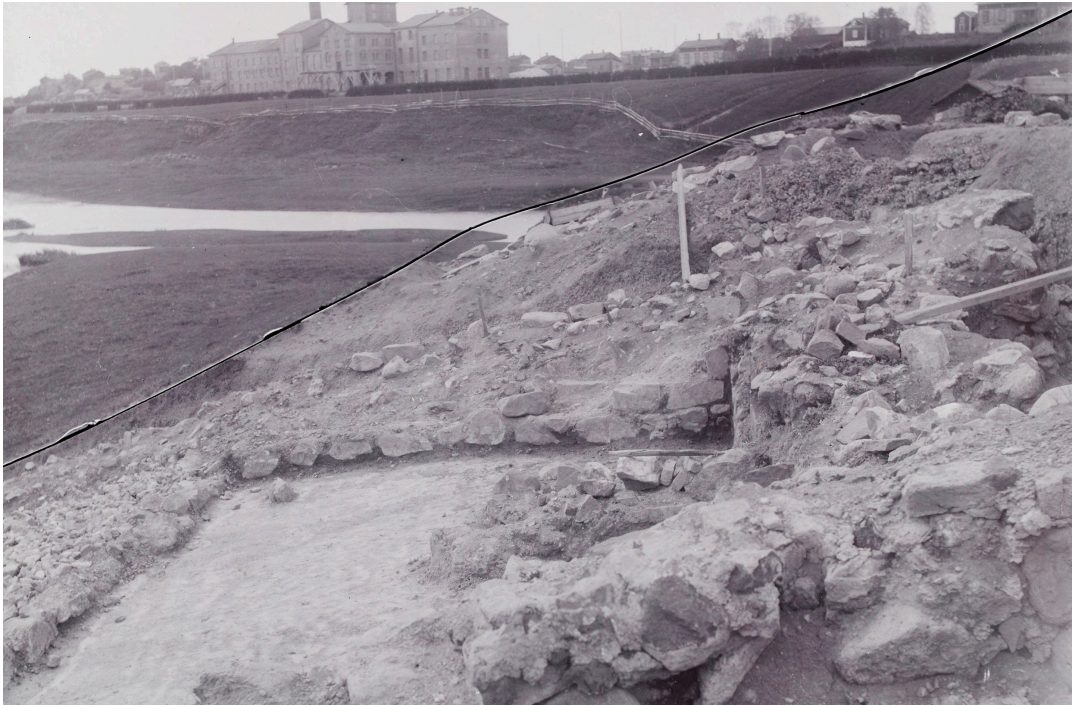
Fig. 9. The foundations of the eastern masonry building seen from the east. In the middle the layer of lime and clay covering the whole building. Photo by J. Ailio / neg. 58372 in Archives of the National Board of Antiquities.

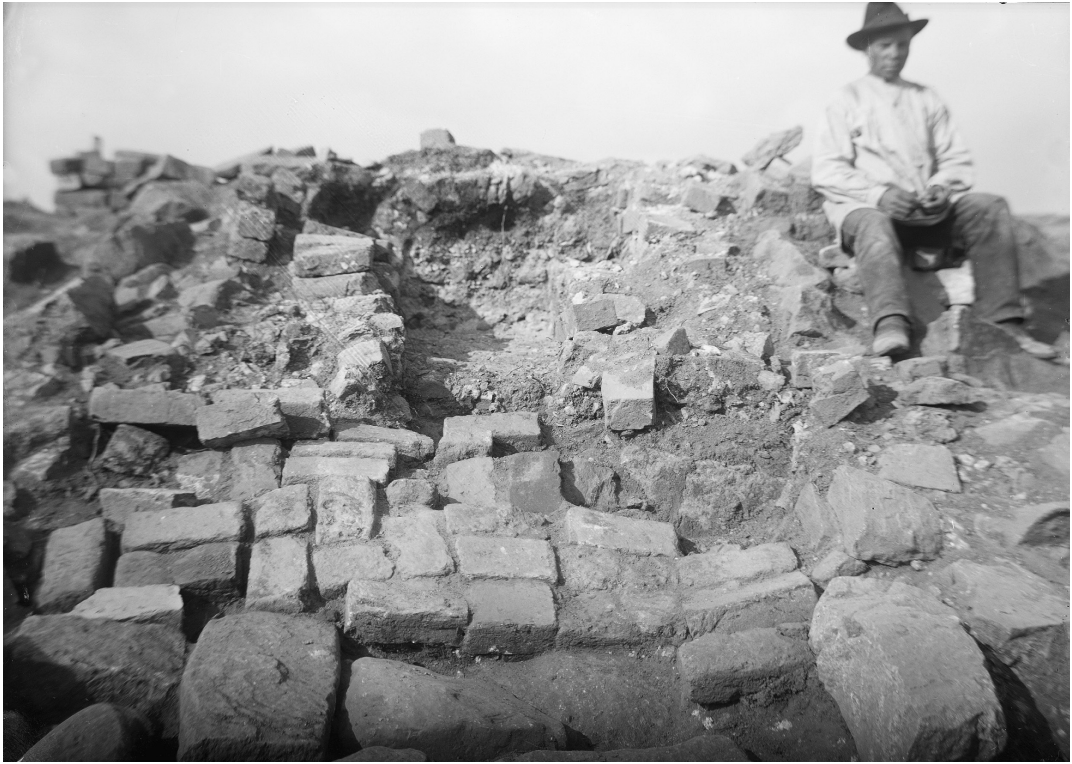
Fig. 11. Heat-storage hypocaust from the south. In front the remains of the brick floor. Photo by J. Ailio, Museum Centre of Turku.
