Medieval Roof Trusses in Churches of Northern Småland

BY ROBIN GULLBRANDSSON

Gullbrandsson, Robin. 2013. Medieval Roof Trusses in Churches of Northern Småland. Lund Archaeological Review 19 (2013), pp. 77–94.

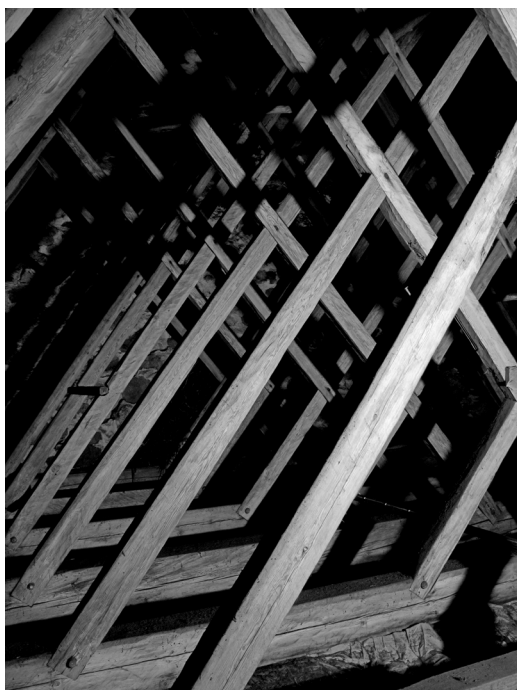
Fig. 2. The crossed strut-beam roof trusses above the nave of the old church in Norra Solberga. The joints with the tie beam have wooden pegs, whereas the others have wrought iron nails. Photo by R. Gullbrandsson.

regarded as an early type of Romanesque roof truss (Linscott & Thelin 2008). In this survey they were found above the chancel of Bredestad church and above the nave and chancel in Norra Solberga old church (Figs. 2, 3 & 4), rebuilt above the nave of Tveta church.

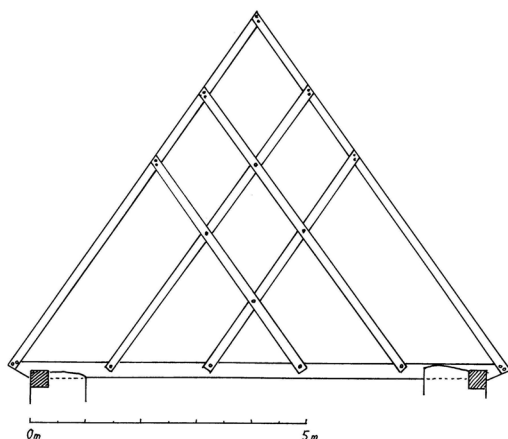
Fig. 3. Section of the roofing of the nave in Norra Solberga. Drawing by R. Gullbrandsson.

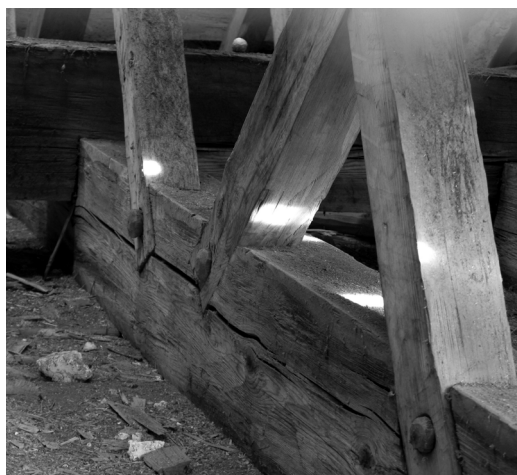
Fig. 4. Detail of tie beams above the chancel in Norra Solberga with wooden pegs shaped like nails. Photo by R. Gullbrandsson.

Possible traces of the mounting of liturgical bells were noticed in two tie beams above the chancel in Norra Solberga and as small separate wooden arms above the chancels of Mellby (vertical on a tie beam) and Vireda (on a rafter foot). In Norra Solberga, any bells in such a position must have been visible from below, as is the case in the church of Kumlabby on Visingsö. In the other cases the bells could have functioned even with a separating ceiling.

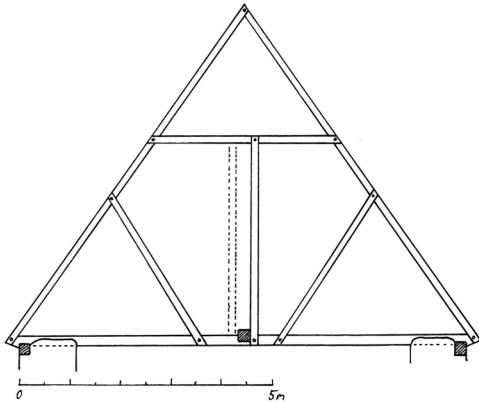
Fig. 5. Section of the roofing above the nave in Bredestad. A collar-beam roof truss with suspended beam, which shift position from side to side of a centred steering beam. Drawing by R. Gullbrandsson.

Two other Romanesque types are represented above the nave of the churches of Bredestad and Bälaryd. These trusses consist of tie beam, rafters, collar beam and two strut beams, and can thus be sorted under the group of “collar-beam roof trusses” (Thelin 2006, pp. 52 f.). The collar beam is supposed to have been introduced during the 13th century (Sjömar 1995, pp. 210 f.; Linscott & Thelin 2008, p. 3) and this group is therefore regarded as younger than the crossed strut-beam trusses (Thelin 2006, pp. 52 f.). Is this an indication that the nave of Bredestad was erected later than the chancel? In Bredestad the collar beam is furnished with centred suspended beams (Figs. 5 & 6) which change place along a central axis (a steering beam) from truss to truss. Collar-beam roof trusses with this trait can also be seen in the church

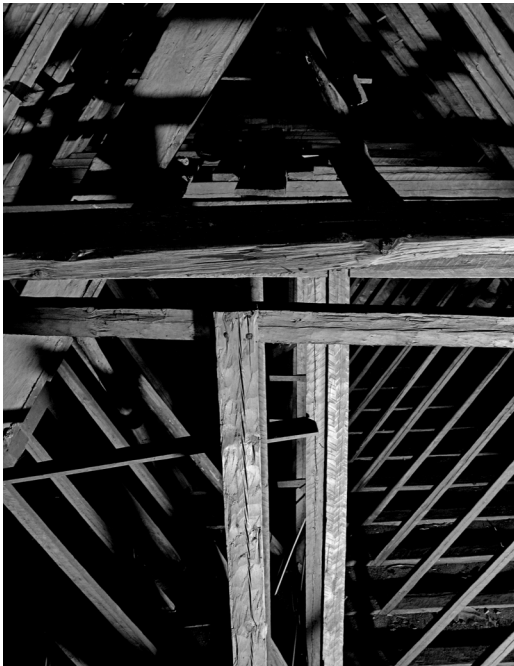
Fig. 6. The roof trusses above the nave in Bredestad. Notice the *sprättäljning* on the suspended beams, apparent in the oblique lightning. Photo by R. Gullbrandsson.

A trace that all of these Romanesque trusses have in common is the technique of cutting. All elements are carefully cut to square angles with a special axe and technique, known as *sprättäljning*, leaving unmistakable traces, a type of fishbone pattern leaping in even bands along the whole piece (Fig. 11). Sometimes, for example in Pelarne, this pattern has vanished since the surface was planed with a draw-knife or *skave*. Hewing by *sprättäljning* has come to be regarded as a characteristic of early medieval timbering in Scandinavia (Sjömar 1988; Storsletten 2002; Linscott 2007; Linscott & Thelin 2008; Melin 2008). Sometime during the 14th century, however, it vanished and was replaced with a cruder technique, hard to distinguish from works of early modern times, thus making the pure stylistic dating of Gothic and Renaissance structures problematic. It has also been argued that *sprättäljning* could have been a prehistoric Nordic technique applied to the new churches, considering the fact that the techniques of handling the timber did not change from the earliest preserved objects up until around mid 14th century (Storsletten 2002).

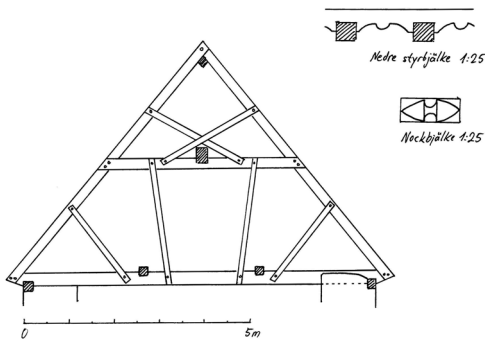
Fig. 7. Section of the roofing above the nave of Bälaryd with three decorated steering plates and ridge purlin. Drawing by R. Gullbrandsson.

Distinctive in Bälaryd are the two crossed strut beams above the collar beam (Fig. 7). This type of truss is almost identical with the one above Dädesjö church, not far from Drev. What is particularly interesting in the roof structure of Bälaryd is the presence of three decorated steering plates and one remaining piece of ridge purlin (Fig. 8). This practical and decorative concept can be found in Småland in the above-mentioned churches of Drev and Dädesjö, Jät church (dated to 1226; Thelin, *Historic Roof Structures*), also in Varend, and Forserum outside Jönköping. In western Östergötland it is present in the churches of Furingstad and Hagebyhöga (dated to the 1120s, Fig. 9). The same type of ridge purlin can be found in the church of Herrestad – where dendrochronology and marks show that it was reused from a 10th-century stave church (Eriksson 2006, pp. 7 & 43; the same might be the case in Flistad in Västergötland according to Eriksson 2006, p. 31) – and Väversunda (dated to 1158), both in western Östergötland, as well as in Kinne-Vedum (dated to 1188) in Västergötland.

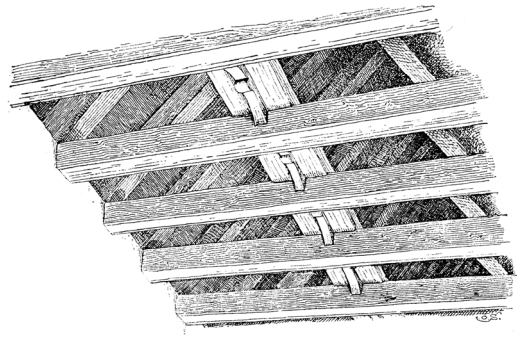
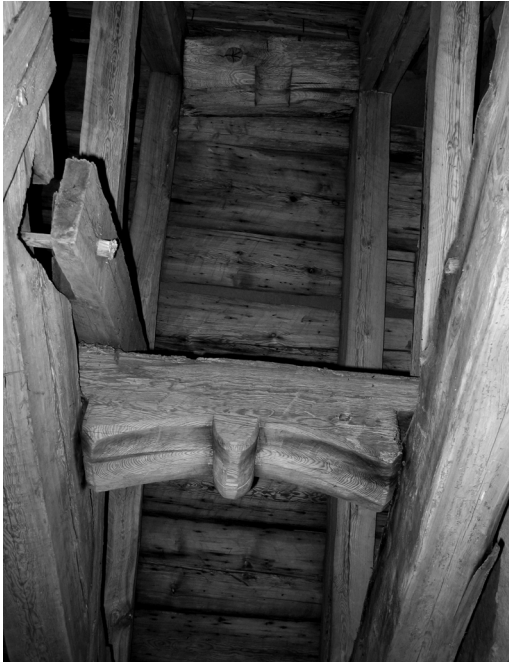
Fig. 8. Decorated steering plate and ridge purlin in Bälaryd. Photo by R. Gullbrandsson.

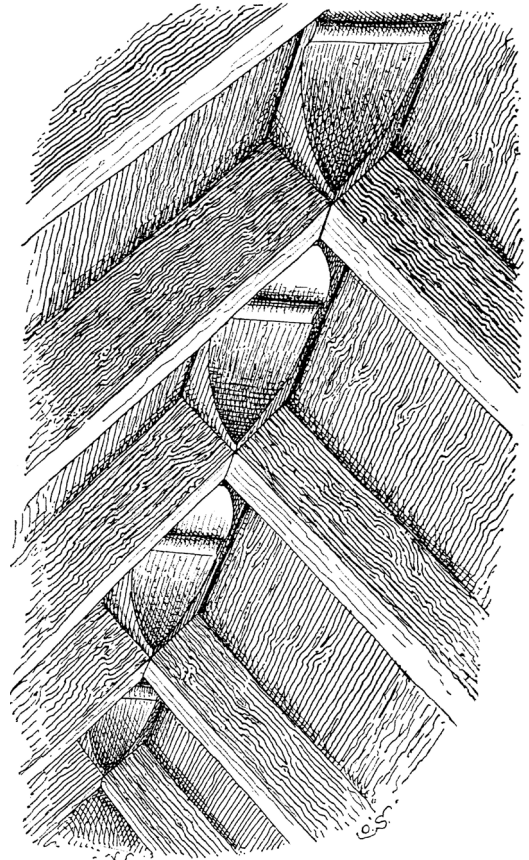
Fig. 9. Reconstruction of the roofing in the church of Hagebyhöga in Östergötland with decorated steering plate and ridge purlin. From Janse (1902).

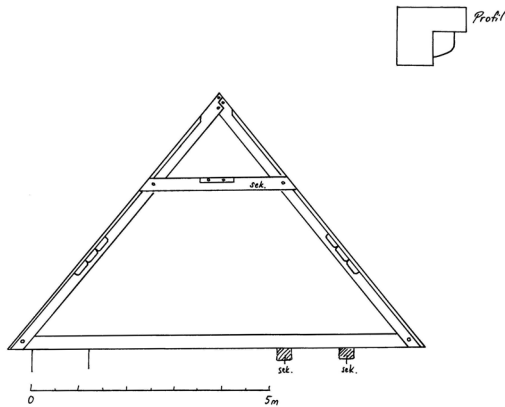
Fig. 10. The former east gable truss of the nave in Bälaryd with simple decoration and trace of a ridge decoration. The collar beam is secondary. Drawing by R. Gullbrandsson.

The present chancel in Bälaryd was supposedly erected during the 13th or 14th century, with the same width and height as the nave. Until then there could not have been any inner ceiling. The trusses were created to be visible from below. Whereas the trusses of the new chancel are much simpler, this must have meant the creation of an inner ceiling to conceal the differing types of trusses. A dendrochronological analysis of the different trusses would surely be a rewarding way to pin down the introduction of the inner ceiling. What is also of interest in Bälaryd is the presence of the L-profiled truss of the old eastern gable of the nave, with decorated though simple furnishing and marks from a lost ridge decoration or ridge cap (Fig. 10, compare Lundberg's reconstruction of the gable peak

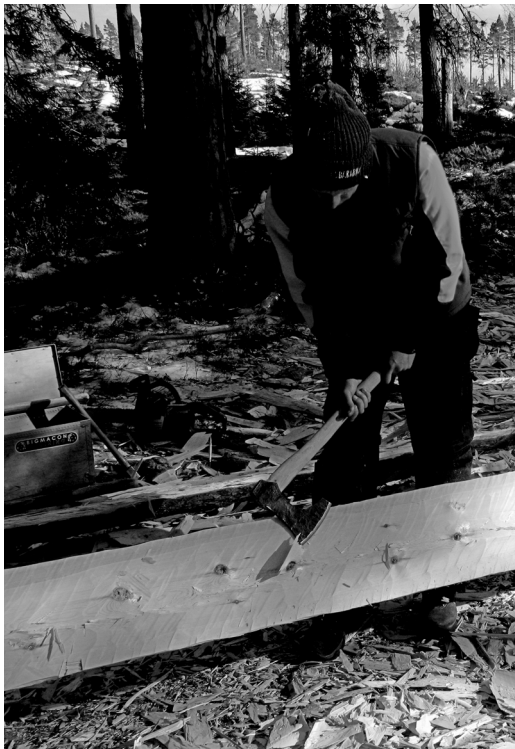
Fig. 11. Carpenter Mattias Hallgren, Traditionsbärarna, cutting boarding for the reconstruction of Södra Råda church, using the technique of *sprättäljning*. Photo by R. Gullbrandsson.

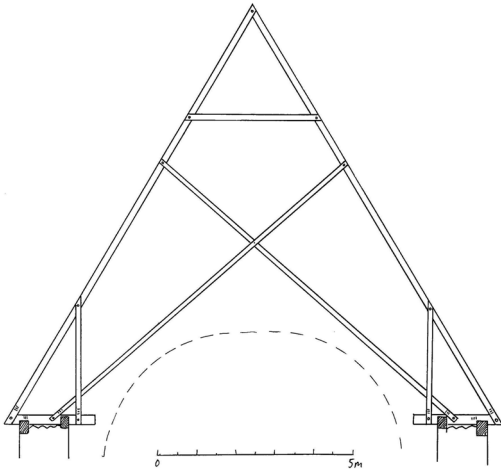
Fig. 12. Section of the Gothic roofing in Säby with characteristic rafter feet and scissor beams. Each part in the rafter foot was numbered before assembly. Drawing by R. Gullbrandsson.

The consistent Gothic structures are few in the area of survey. Only two are completely preserved. The most imposing Gothic roofing is to be found in Säby, the largest of the preserved medieval churches in the area (Fig. 12). There are 34 trusses with an angle of 60 degrees and a span of almost 10 metres (almost the same in height). Here we find the types of trusses developed to coexist with a vaulted church room. They consist of rafter feet, double wall plates on top of the masonry, collar beam and scissor beams. In between every vault there is a truss with tie beam. All parts are marked with Roman numbers, indicating that the parts were completed and matched to another on the ground and then put together on top of the church according to the markings (compare Hallgren *et al.* 2013). This probably took place when the church was enlarged into a vaulted hall church in the 15th century. An enlargement to the east of Tveta church has remains of altered Gothic trusses.

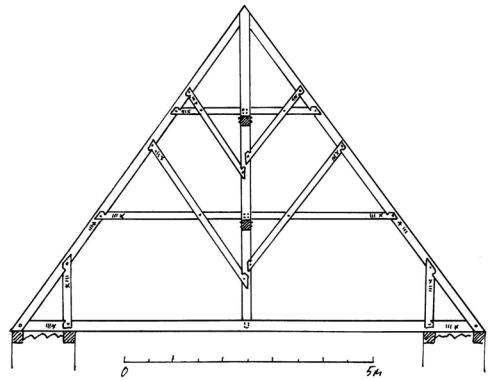
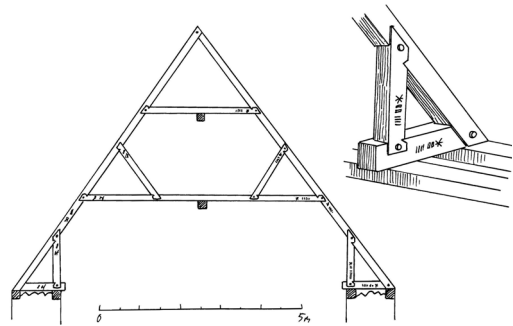
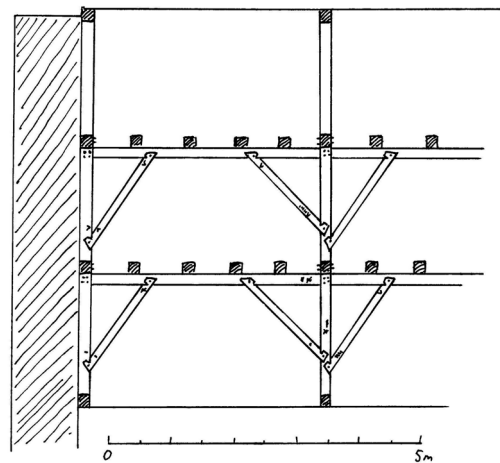
Fig. 13. Sections of the late Gothic roofing in Askeryd with longitudinal beams and king posts. A rare phenomena in medieval Götaland? Every part in the construction is numbered, with separate systems for north and south. All joints are notched. Drawings by R. Gullbrandsson.

Askeryd church boasts the only completely intact construction with longitudinal beams and king posts (Figs. 13 & 14). All parts are numbered carefully, with different systems for

north versus south (carved flags and lines). With the introduction of longitudinal supportive systems during the 13th century – for example, in France – the Gothic trusses and their hierarchy developed further, to reach a peak during the late medieval period, at which time the system got common in Scandinavia (*Kulturbistoriskt lexikon XVIII* 1974, pp. 68 ff.; Hoffsummer *et al.* 2011). The dating of Askeryd can be connected with the creation of a hall church in the 15th century. We also find trusses with longitudinal beams and king posts, though smaller in scale, above what seems to be a never-completed west tower for the church of Höreda. The church burned around 1400 and/or during the Danish campaign of 1520–1521 (Törnvall 1996; Ödeén 2008), and thus it could be argued that the construction belongs to the 15th or 16th century. A single truss from a similar construction has been noticed by the author above the old chancel of Järnsås church.

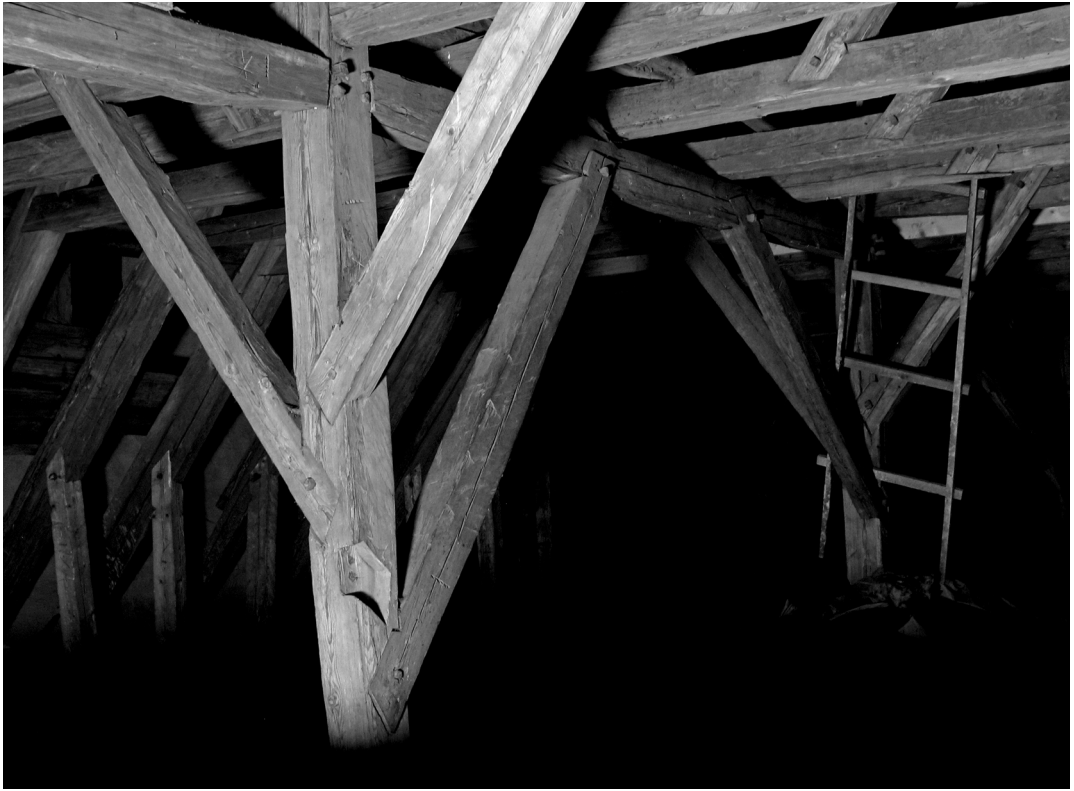
Fig. 14. Detail of the roofing in Askeryd with the lower part of two king posts. Photo by R. Gullbrandsson.

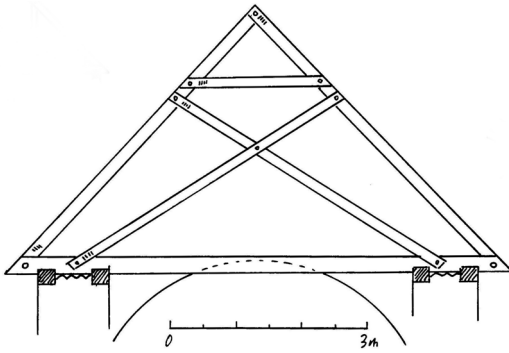
Fig. 15. Section of the roofing in Marbäck. A merger of Romanesque and Gothic traits. The tie beam is still in use but instead of strut beams we find scissor beams and the double wall plates, which are usually connected with rafter feet. Each part is numbered. Drawing by R. Gullbrandsson.

ning and both have numbering. Marbäck has many characteristics of the Gothic trusses: double wall plates, scissor beams and collar beam, but no strut beams between rafter and tie beam (Fig. 15). Probably the trusses of Marbäck can be linked to the extension of the church and the building of a new chancel of the same width as the nave during the second half of the 13th century. When the interior was vaulted during the Late Middle Ages some of the tie beams were cut, without rafter feet being inserted, and this weakened the construction. The form in Vireda is almost Romanesque, with “collar-beam roof trusses” (double collar beams and two strut beams). Shingles on the old chancel gable have been dated to 1344 (Ullén 1983, p. 134). The trusses above the hall church of Mellby are also

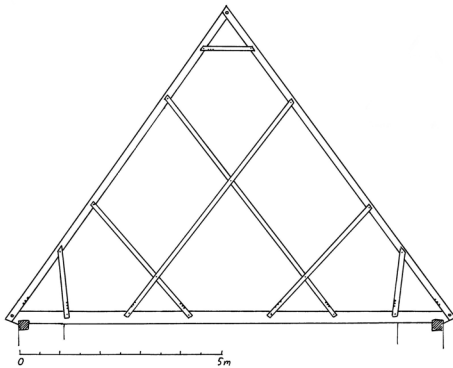
Fig. 16. Section of the roofing in Mellby. The trusses are Romanesque in shape but date to the end of the 13th and the beginning of the 14th centuries, probably going back to an older roof. Drawing by R. Gullbrandsson.

Romanesque in shape (Fig. 16). Some parts are clearly hewn by *sprättäljning* and there are two different systems of numbering, discretely carved marks on the edges versus simple lines. Dendrochronological analysis indicates that the roof structure was rebuilt in part or whole in the middle of the 14th century with re-used trusses, half a century older. The

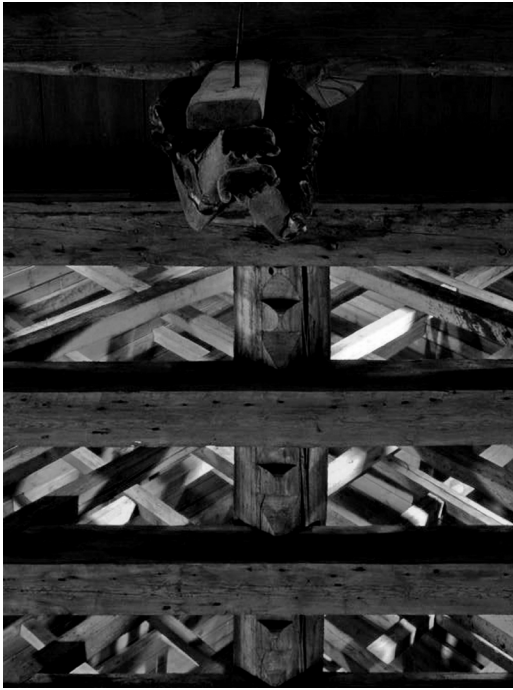
Fig. 17. The crossed strut-beam roof trusses above the nave in Forserum; since the architect Erik Lundberg's restoration in 1935 they are again visible in the church interior. Notice the decorated steering plate. Photo by R. Gullbrandsson.
